# Arborist Associates Ltd.

## An Arboricultural Assessment on Lands at 'Glenamuck North', Kilternan, Dublin 18.

Prepared for: Durkans Glenamuck Developments Limited

Date: 26<sup>th</sup> November 2025

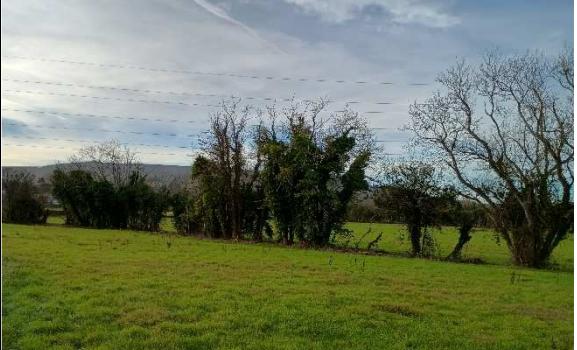
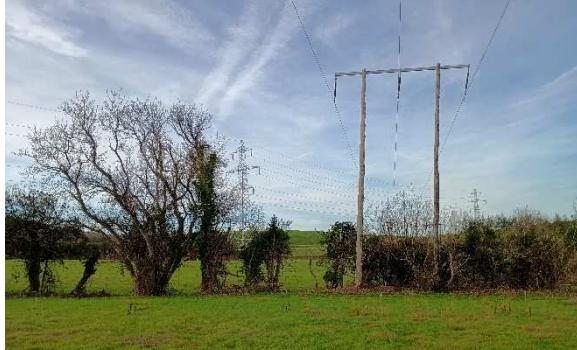
Tree No.	Tree Species	Ht. (m)	Stem Dia. (mm)	Branch Spread (m)				C-Ht. (m)	Age Class	Phys. Con.	Structural Condition Other Comments	Preliminary Recommendation	ULE	Cat. Grade	RPA (radius) (m)
				N	S	E	W				N-north S-south E-east W-west C-Ht.-crown height, Dia.-diameter Phys.-physiological.	ULE-useful life expectancy Cat.-category, A-average			
				<b>A condition assessment of the tree vegetation on Lands at 'Glenamuck North', Kilternan, Dublin 18.</b>											
Hedge No.6	Ash <i>Fraxinus excelsior</i> Holly <i>Ilex aquifolium</i>			<p>It extends at ninety degrees from Hedge no. 5 in a broadly east to west direction.</p> <p>It is of a mature age class in fair condition physiologically and fair/ poor condition structurally. There is a small stream flowing along the northern side of the hedge. The western end of the hedge has trees on both sides of the stream forming a double row. The hedge has been cut down at the eastern end to clear the overhead powerlines at this location. It has been allowed to grow in an unmanaged manner and the undergrowth has recently been cleared, mainly on the north side, leaving the trees.</p>

A6 -- 2N 3S --								It requires no work at the present time.	--	C2	--
				<p>It contains the following tree.</p>											
0894	Ash <i>Fraxinus excelsior</i>	12	320/ 130/ 320/ 340 4 stems	5	5	6	1	4	Early Mature	Poor	Poor It is multiple-stemmed from near base with heavy undergrowth of Holly, Sycamore and Bramble around the base. Significant excavations have taken place in the root protection area of the tree, c.1m off the base on the west side and part of the south side, impacting the root zone and severing roots. It has been infected with 'Ash Dieback Disease'	I would recommend its <u>removal</u> as part of management.	<10	U	9.97

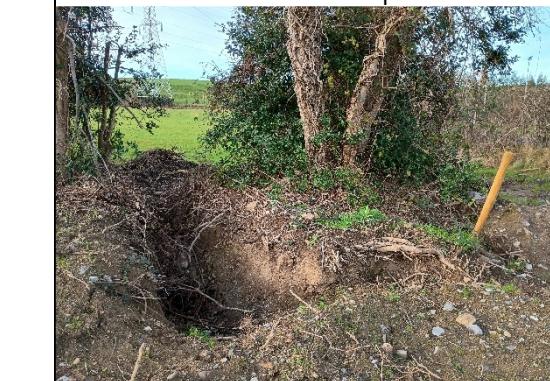
Tree No.	Tree Species	Ht. (m)	Stem Dia. (mm)	Branch Spread (m)				C-Ht. (m)	Age Class	Phys. Con.	Structural Condition Other Comments	Preliminary Recommendation	ULE	Cat. Grade	RPA (radius) (m)			
				N	S	E	W				N-north S-south E-east W-west C-Ht.-crown height, Dia.-diameter Phys.-physiological.	ULE-useful life expectancy Cat.-category, A-average						
											(Hymenoscyphus fraxineus) with dieback evident in the crown. It has no potential.

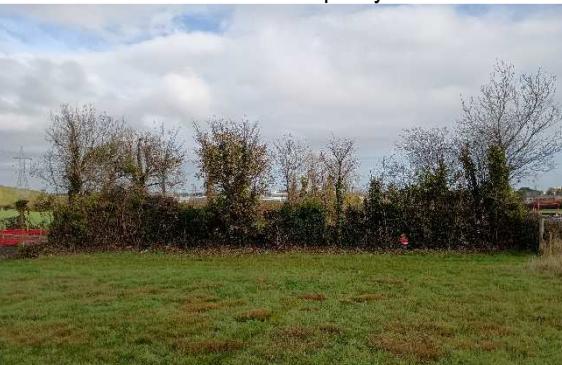
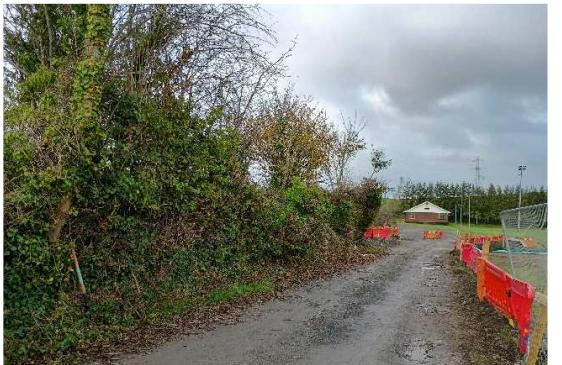
Hedge No.7	<b>Ash</b> <i>Fraxinus excelsior</i> <b>Holly</b> <i>Ilex aquifolium</i> <b>Hawthorn</b> <i>Crataegus monogyna</i> <b>Sycamore</b> <i>Acer pseudoplatanus</i>			<p><b>It extends at ninety degrees from Hedge No. 6 at the southern end of Hedge No.5 in a broadly north to south direction outside the site areas red line boundary.</b></p> <p>It is of a mature age class in fair condition physiologically and fair/ poor condition structurally. It has been allowed to grow in an unmanaged manner and consists mainly of young, sapling Ash and Sycamore trees starting to develop above an understorey of Holly and Hawthorn. Ivy and Bramble are colonising the line. It has been cut recently on the eastern side to maintain clearance over the adjacent roadway and a central section has been removed for the road reservation creating a break in the hedge and the section of hedge south of break is of the better quality.</p>

It requires no work at the present time.	--	C2	--

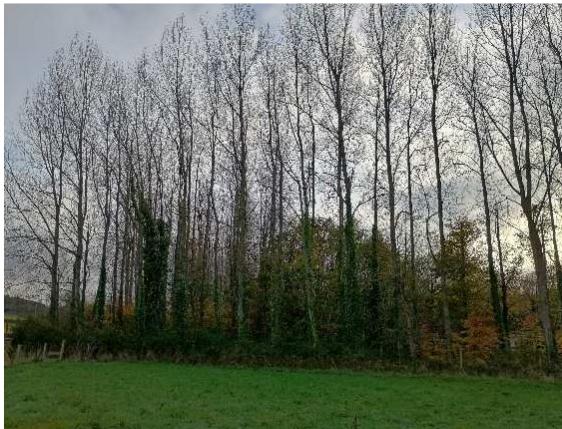
Tree Line No. 1	Poplar <i>Populus nigra</i>	They are a visually prominent line of trees growing just off the southern boundary of the site area. They are single stem trees, of an early mature age class in fair condition both physiologically and structurally. They were closely planted and they have grown up together to form part of the one group canopy formation providing support/shelter to one another. Ivy cover is starting to develop on some of the stems. Their crowns extend out over the site boundary and there is some minor storm damage in some of the trees.										Make safe large size dead/unstable growth.	10-20	C2	6.24

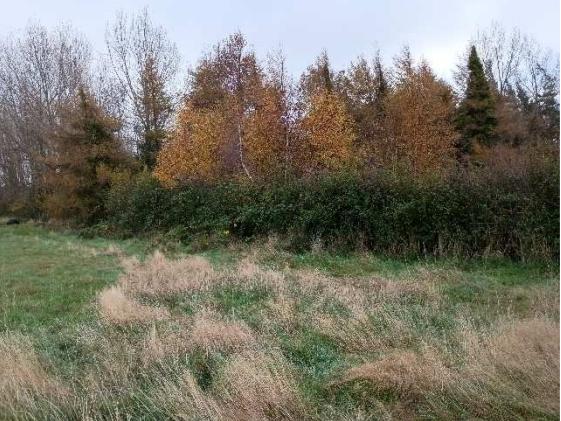
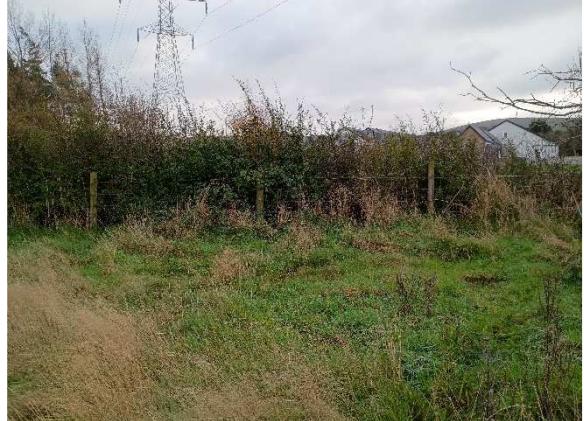
Tree No.	Tree Species	Ht. (m)	Stem Dia. (mm)	Branch Spread (m)				C-Ht. (m)	Age Class	Phys. Con.	Structural Condition Other Comments		Preliminary Recommendation		ULE	Cat. Grade	RPA (radius) (m)
				N	S	E	W				N-north S-south E-east W-west C-Ht.-crown height, Dia.-diameter Phys.-physiological.		ULE-useful life expectancy Cat.-category, A-average				
		A24	A500	A3N, 3S, 3E, 3W		A3											
Tree No. 1	Larch <i>Larix sp.</i>	16	450	4	3	4	4	2	Early Mature	Fair / Good	Fair It is a single stem tree growing at the west end of Tree Line No. 1, just of the southern site boundary. Heavy Ivy growth extends high into its crown, increasing its wind sail. Bramble is colonising the lower crown. Its crown extends out to the north over the site boundary.		Management is outside the site area.		20+	B1	5.4
Hedge No.9	Hawthorn <i>Crataegus monogyna</i> Pyracantha <i>Pyracantha</i> Bramble <i>Rubus fruticosus</i>	<p><b>It extends on from Tree no. 1 in a broadly east to west direction along the southern boundary of the site area.</b></p> <p>It is of an early mature age class in fair /good condition physiologically and fair condition structurally. It is growing over a post and wire fence and is located on just off the site boundary. Ivy and Bramble are colonising the line. It has been cut in the past to control height and spread but would benefit from cutting to shape and tidy.</p>

It would benefit from cutting to selected height and width to shape and tidy.		--	C2	--

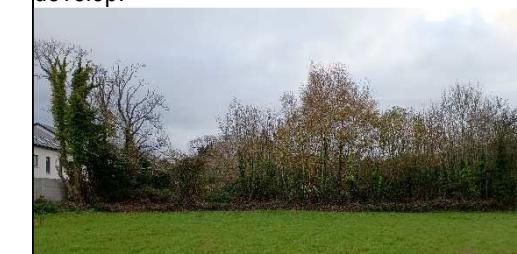
Tree No.	Tree Species	Ht. (m)	Stem Dia. (mm)	Branch Spread (m)				C-Ht. (m)	Age Class	Phys. Con.	Structural Condition Other Comments	Preliminary Recommendation	ULE	Cat. Grade	RPA (radius) (m)
				N	S	E	W				N-north S-south E-east W-west C-Ht.-crown height, Dia.-diameter Phys.-physiological.	ULE-useful life expectancy Cat.-category, A-average			
	Salix sp. <b>Sycamore</b> Acer <i>pseudoplatanus</i>										They are being drawn up for light due to competition, affecting their structure and they have been left more open/exposed by the site clearance works undertaken on the adjoining lands. They would benefit from selective thinning to give space to the better trees to develop.
