Proposed Residential Development,
(Southern Site), Glenamuck,
Kilternan, Dublin 18

Stage 1 Quality Audit Report

Document Ref:	P25217-PMCE-XX-XX-RP-QA-3_0002				
---------------	--------------------------------	--	--	--	--

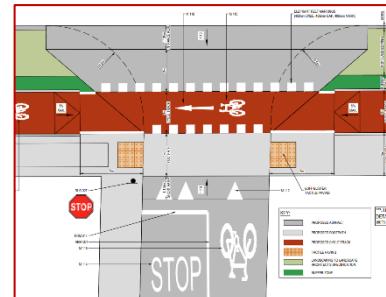
A.1.1 Delineation between Cycle Track and Footway at Development Access

The cycle track on the Glenamuck District Distributor Road is indicated as being raised to the same level as the adjacent footway on the approach to, and through, the proposed raised-table crossing at the development vehicular access junction.

This could result in visually-impaired or partially-sighted pedestrians inadvertently straying into the cycle track, or enter the carriageway.

Similarly, the edge of the footpath on the development side of the crossing may be insufficiently delineated, possibly resulting in visually-impaired or partially-sighted pedestrians straying into the side road carriageway.

A level difference should be provided between the footway and cycle track on the approaches to, and through, the proposed raised-table crossing. This could be achieved, for example, by a 60mm high bevelled kerb which would facilitate vehicle crossover, whilst providing delineation for visually-impaired pedestrians. Similarly, delineation should be provided between the footway and the side road carriageway.

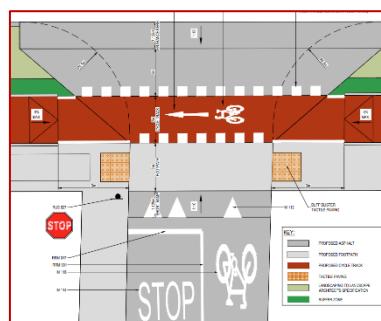
A.1.2 Extent of Tactile Paving at Crossing of Development Access

The width of the tactile paving within the footpath at the raised-table crossing of the side road at the new junction with the Glenamuck District Distributor Road is not indicated as extending over the full width of the interface between the footpath and the raised-table, which could result in a visually impaired pedestrian inadvertently entering the crossing without being adequately warned.

The width of the tactile paving at the crossing should extend over the full width of the interface between the footpath and the crossing.

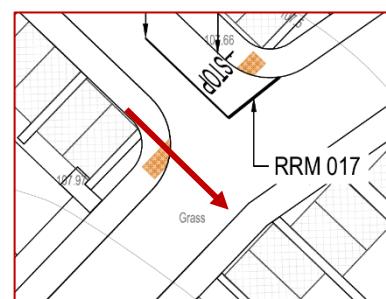
A.1.3 Crossing Points at Junction Corners

Some pedestrian crossing points have been indicated at the corners of internal junctions within the development.

This layout may lead to confusion for visually impaired pedestrians, as depending on the direction of their approach to the dropped kerb, they may misinterpret the direction of the crossing.

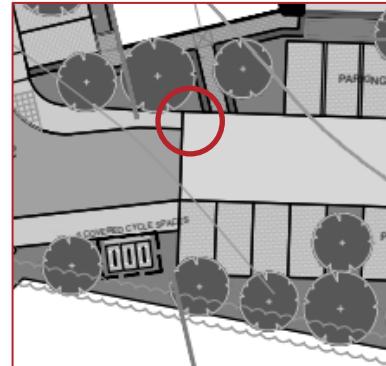
The 1.2m refuge area has been indicated on the cross sections as being provided on one side of the Home Zone only, however footpaths terminate at the Home Zone on both sides in some locations.

The absence of measures to advise visually-impaired pedestrians when they are entering/leaving shared areas increases the difficulty for these road users in safely & independently navigating the proposed road layout.

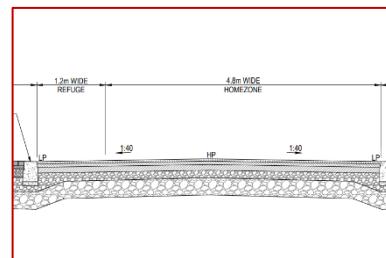
The absence of a suitable delineator could lead to difficulties for visually impaired pedestrians safely & independently navigating the proposed Home Zone areas.

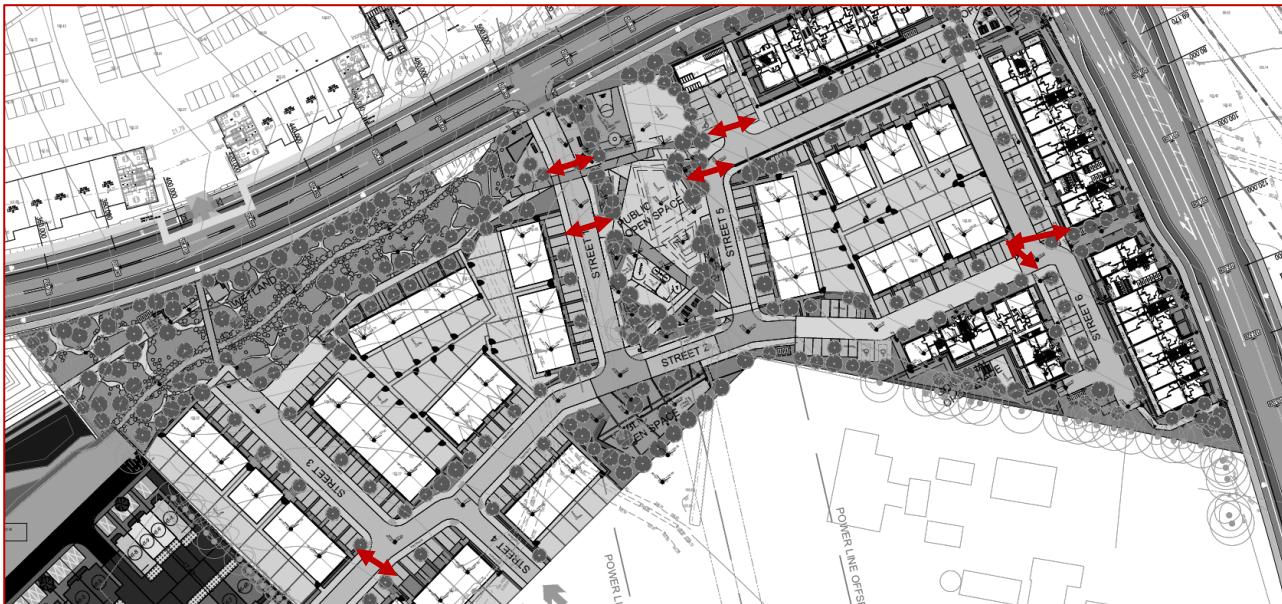
A.1.7 Pedestrian Desire Lines

No crossing facilities have been indicated at a number of likely pedestrian crossing desire lines within the proposed development, including between residential units & the open space areas and across side roads at internal junctions.

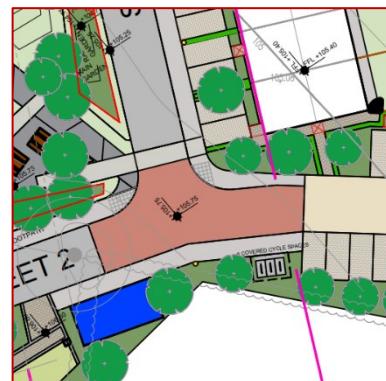
If adequate delineation is not provided between the top of the raised table and the adjacent footpath visually impaired pedestrians could inadvertently enter the carriageway.

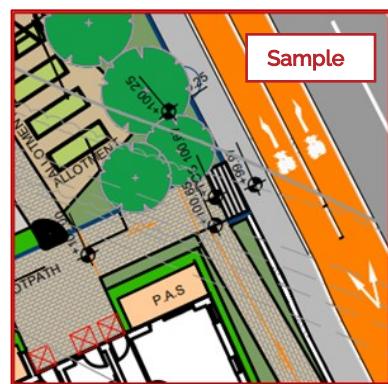
Hazard warning tactile paving has not been indicated at the top and bottom of these steps. The absence of warning tactile paving at these locations may lead to visually impaired pedestrians being insufficiently advised of the hazard.

Hazard warning tactile paving should be provided at the top and bottom of steps within the development.

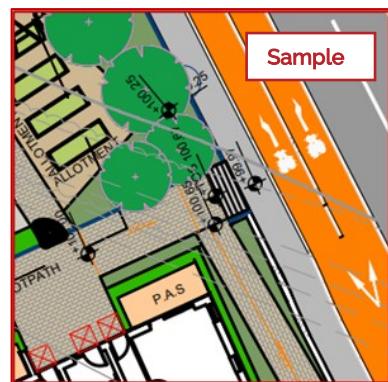
This would increase the difficulty experienced by the mobility impaired, who may have to travel an unnecessarily lengthy distance when accessing/egress thing the development, for example via the main access on the Glenamuck District Distributor Road.

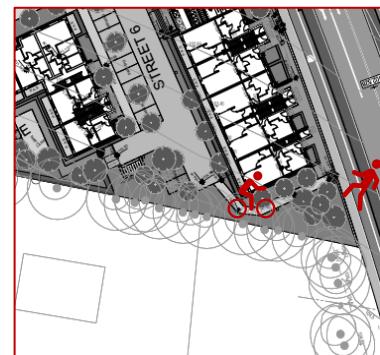
If the link is not wide enough to safely accommodate both pedestrians and cyclists, this may lead to pedestrians travelling on the adjacent verge.

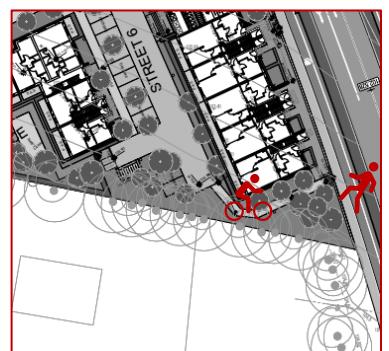
It is unclear if the width of the footpath is sufficiently wide enough to accommodate the expected peak volume of cyclists and pedestrians.

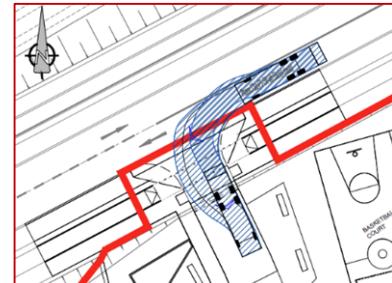
Following drivers on the Distributor Road may not anticipate a vehicle coming to a halt when entering the development junction, leading to late braking and rear-end shunt collisions.

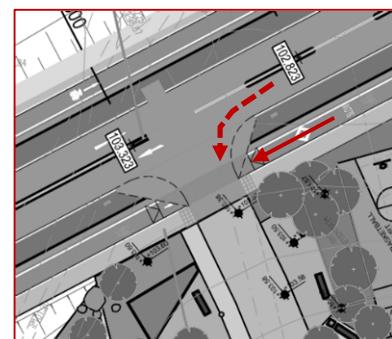
The likely angle of approach of a left-turning vehicle to the partially set-back cycle track at the development access junction may not afford adequate visibility for left-turning drivers towards approaching cyclists, as the drivers would have to turn and look over their shoulder, and could result in unsafe cycle track crossings by vehicles leading to collisions with cyclists..

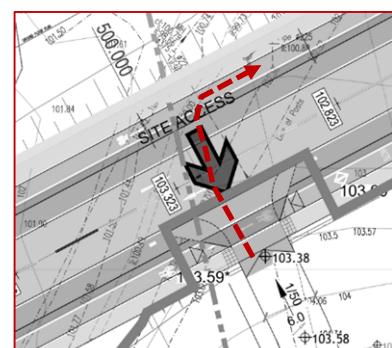
There are one-way cycle tracks on either side of the Glenamuck District Distributor Road, separated from the carriageway by a grass verge. No arrangement has been indicated on the northern side of the GDDR carriageway to cater for cyclists travelling to/from the cycle track on this side of the GDDR and the development.

This could lead to cyclists choosing to travel in the incorrect direction within the cycle track on the eastern side of the GDDR, increasing the risk of collisions with cyclists travelling in the opposing direction, or to cyclists remaining within the carriageway, increasing the risk of being struck by a vehicle.

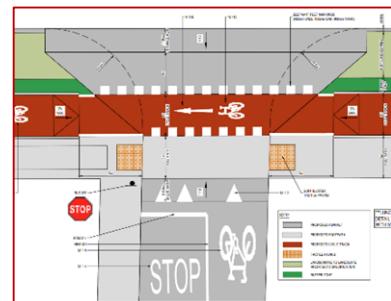
This could result in visually-impaired or partially-sighted pedestrians inadvertently straying into the cycle track where they are at an increased risk of being struck by a cyclist, and from the cycle track they could inadvertently enter the carriageway where they are at an increased risk of being struck by a vehicle.

Similarly, the edge of the footpath on the development side of the crossing may be insufficiently delineated, possibly resulting in visually-impaired or partially-sighted pedestrians straying into the side road carriageway where they are at an increased risk of being struck by vehicle.

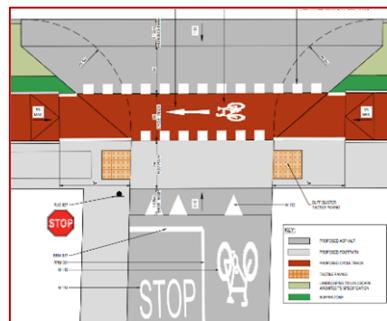
The width of the tactile paving within the footpath at the raised-table crossing of the side road at the new junction with the Glenamuck District Distributor Road is not indicated as extending over the full width of the interface between the footpath and the raised-table, which could result in a visually impaired pedestrian inadvertently entering the crossing without being adequately warned, where they are at an increased risk of being struck by vehicle.

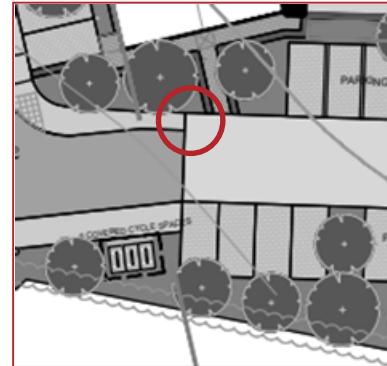
The 1.2m refuge area has been indicated on the cross sections as being provided on one side of the Home Zone only, however footpaths terminate at the Home Zone on both sides in some locations.

The absence of measures to advise visually-impaired pedestrians when they are entering/leaving shared areas increases the difficulty for these road users in safely & independently navigating the proposed road layout.

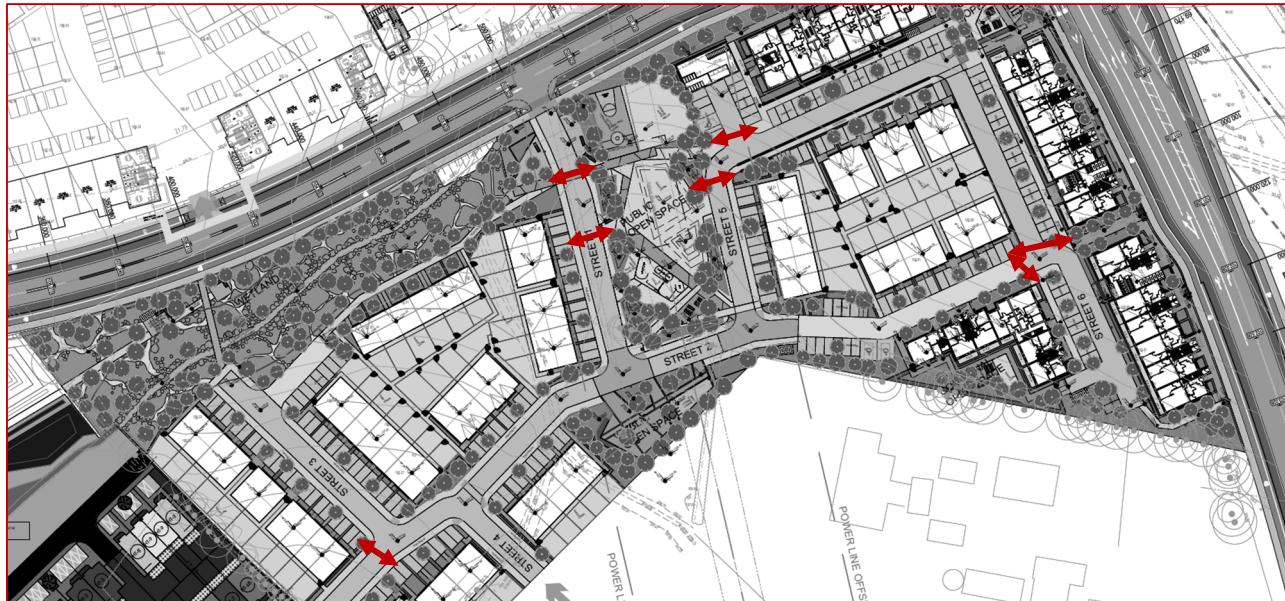
3.8 Pedestrian Crossing Desire Lines

Summary: A number of likely pedestrian crossing desire lines are not accommodated by the proposed crossings, possibly resulting in unsafe crossings.

No crossing facilities have been indicated at a number of likely pedestrian crossing desire lines within the proposed development, including between residential units & the open space areas and across side roads at internal junctions.

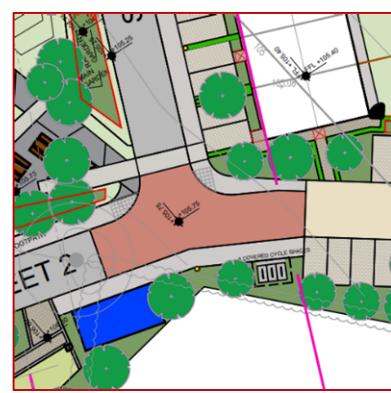
Raised tables have been indicated at a number of internal junctions within the proposed development. It is unclear, at this early stage in the design development, if a level difference would be provided between the top of the raised table and the adjacent footpath, away from where tactile paving has been indicated at pedestrian crossings, or if the footpath will be flush with the top of the raised table.

If adequate delineation is not provided between the top of the raised table and the adjacent footpath visually impaired pedestrians could inadvertently enter the carriageway where they are at an increased risk of being struck by a vehicle.

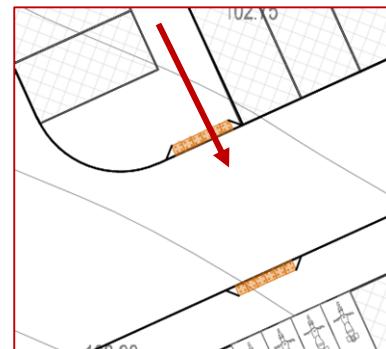
There is an in-line approach to the northern crossing point, which could lead to visually-impaired pedestrian inadvertently stepping over the tactile paving and entering the carriageway, where they are at risk of being struck by a vehicle.

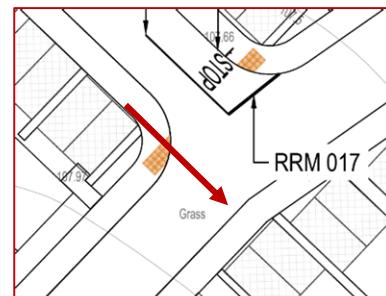
In addition, dropped kerbs on corners may increase the risk of vehicles overrunning the footpath & crossing locations when turning, presenting an increased risk of pedestrian/vehicle collisions at the crossing points.

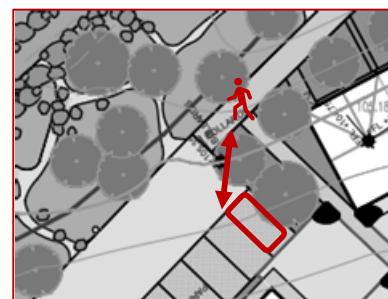
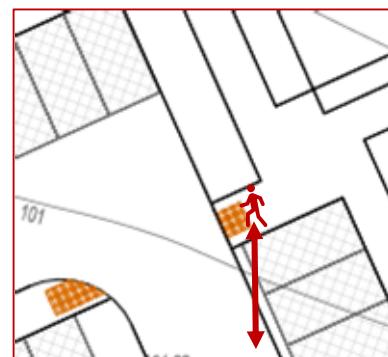
Planting has been indicated throughout the development. In some locations the proposed planting adjacent to pedestrian crossings may impede inter-visibility between a pedestrian waiting at, or commencing, a crossing and an approaching driver, leading to unsafe crossings.

In addition, any number of pedestrian crossings have been indicated at locations adjacent to parking spaces. Parked vehicles may impede inter-visibility between pedestrians and approaching drivers, leading to unsafe crossings and a risk of vehicle/pedestrian collisions.

Adequate inter-visibility should be provided at all crossings.

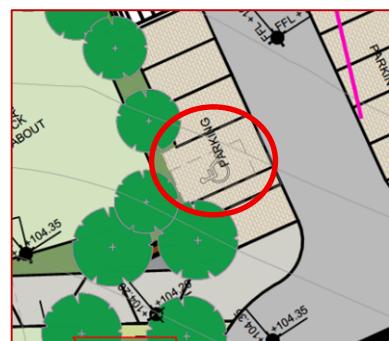
3.13 Travel to/from Accessible Parking

A mobility impaired parking space has been indicated on the side road off of Street 5, however there is no footpath indicated adjacent to the parking space, and the nearest dropped kerb is around the corner.

This layout would result in mobility impaired vehicle occupants having to travel within the carriageway to/from the dropped kerb location, where there is an increased risk of being struck by a vehicle.

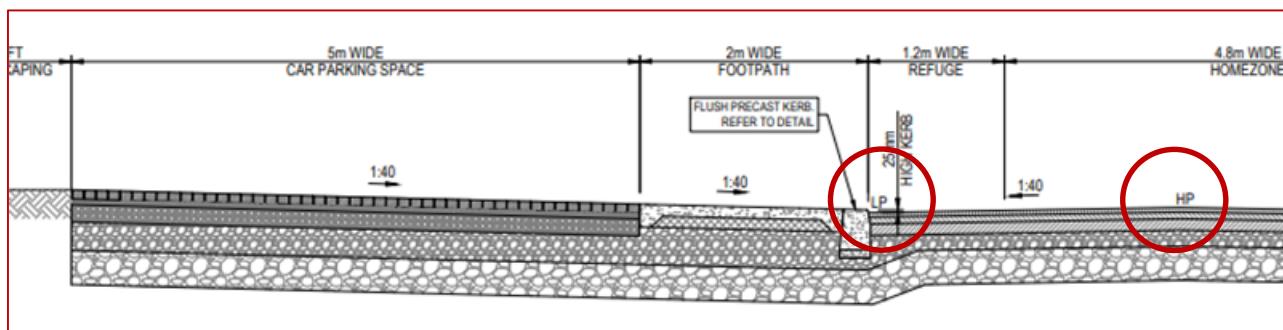
No gullies have been indicated on the carriageway of Street 5. The proposed arrangement whereby the footpath is located in front of the car parking spaces could present run-off from reaching the proposed SuDS Permeable Paving Parking Bays on one side may result in the carriageway being insufficiently drained. Should the carriageway be unable to adequately shed surface run-off, this could result in ponding leading to a loss of traction for vehicles and cyclists, in particular during wet or icy weather.

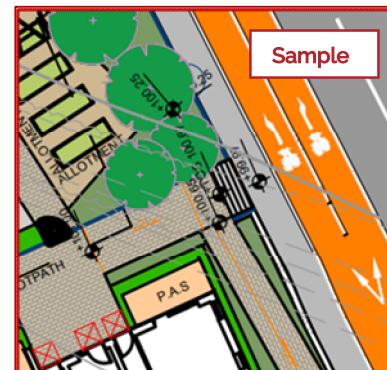
Summary: Hazard warning tactile paving has not been indicated at the top and bottom of the steps within the development.

Hazard warning tactile paving has not been indicated at the top and bottom of these steps. The absence of warning tactile paving at these locations may lead to visually impaired pedestrians being insufficiently advised of the hazard resulting in trips and falls.

Hazard warning tactile paving should be provided at the top and bottom of steps within the development.

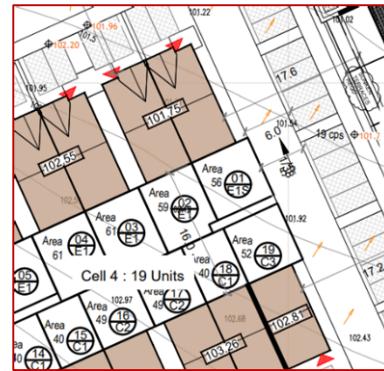
Summary: The side boundary walls to Units 56 and 52 extend to the Street 6 carriageway edge, increasing the risk of material damage collisions by vehicles with the boundary and may lead to pedestrians travelling within the adjacent carriageway.

The side boundary walls to Units 56 & 52 have an indicated as extending to the edge of the Street 6 carriageway. It is unclear from the information provided what type of boundary is proposed at this location, nevertheless the proximity of the boundary to the traffic carriageway increases the likelihood of material damage collisions between vehicles and the boundary.

In addition, the resulting discontinuity in the footpath on the western side of Street 6 could lead to pedestrians entering the adjacent carriageway, where they are at an increased risk of being struck by a vehicle.

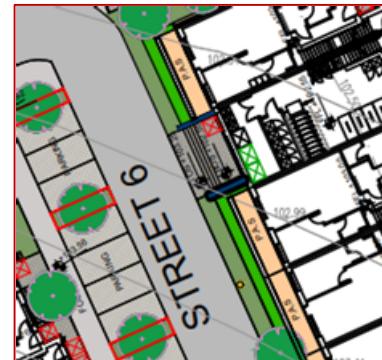
Steps have been indicated to/from Duplex Block C on the eastern side of Street 6 which exit directly onto the carriageway at this location.

Drivers may not anticipate a pedestrian to exit directly into the carriageway and, therefore, may have insufficient time to react resulting in an increased risk of vehicle-pedestrian collisions.

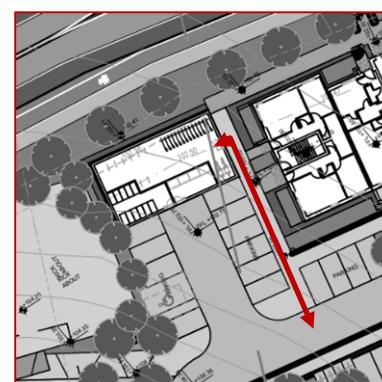
A bike store is indicated to the west of Duplex Block A, which would be accessed via a footpath. It is unclear if the width of the footpath is sufficiently wide enough to accommodate the expected peak volume of cyclists and pedestrians, leading to some pedestrians or cyclists travelling on the adjacent verge, leading to an increased risk of slips, trips or falls, particularly in wet or icy weather.

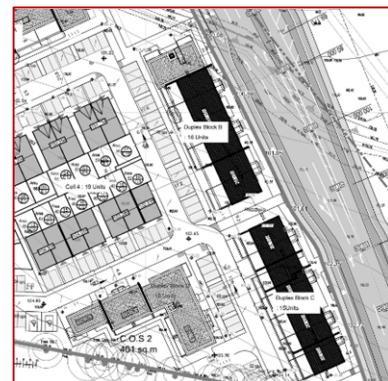
4.1 No accessible parking spaces appear to be indicated in the vicinity of Duplex Block B and C within the proposed development. This may lead to difficulties for mobility impaired residents of the apartments, particularly wheelchair users, when entering/exiting their vehicle should they have to park in standard parking spaces.

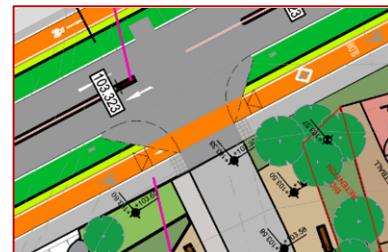
4.2 Trees have been indicated adjacent to the development access onto the Glenamuck District Distributor Road on Drawing NMP_Cowley Lands_Landscape Master Plan.

A note in Drawing 4426-MHT-XX-ZZ-DR-T-20-0011 (Rev.P01) and indicates that no trees will be provided in this area to facilitate the visibility splay for exiting drivers.

If trees are provided within the visibility splay this may impede visibility for exiting drivers resulting in unsafe exiting manoeuvres and possible vehicle/cyclist or side-on vehicle collisions.

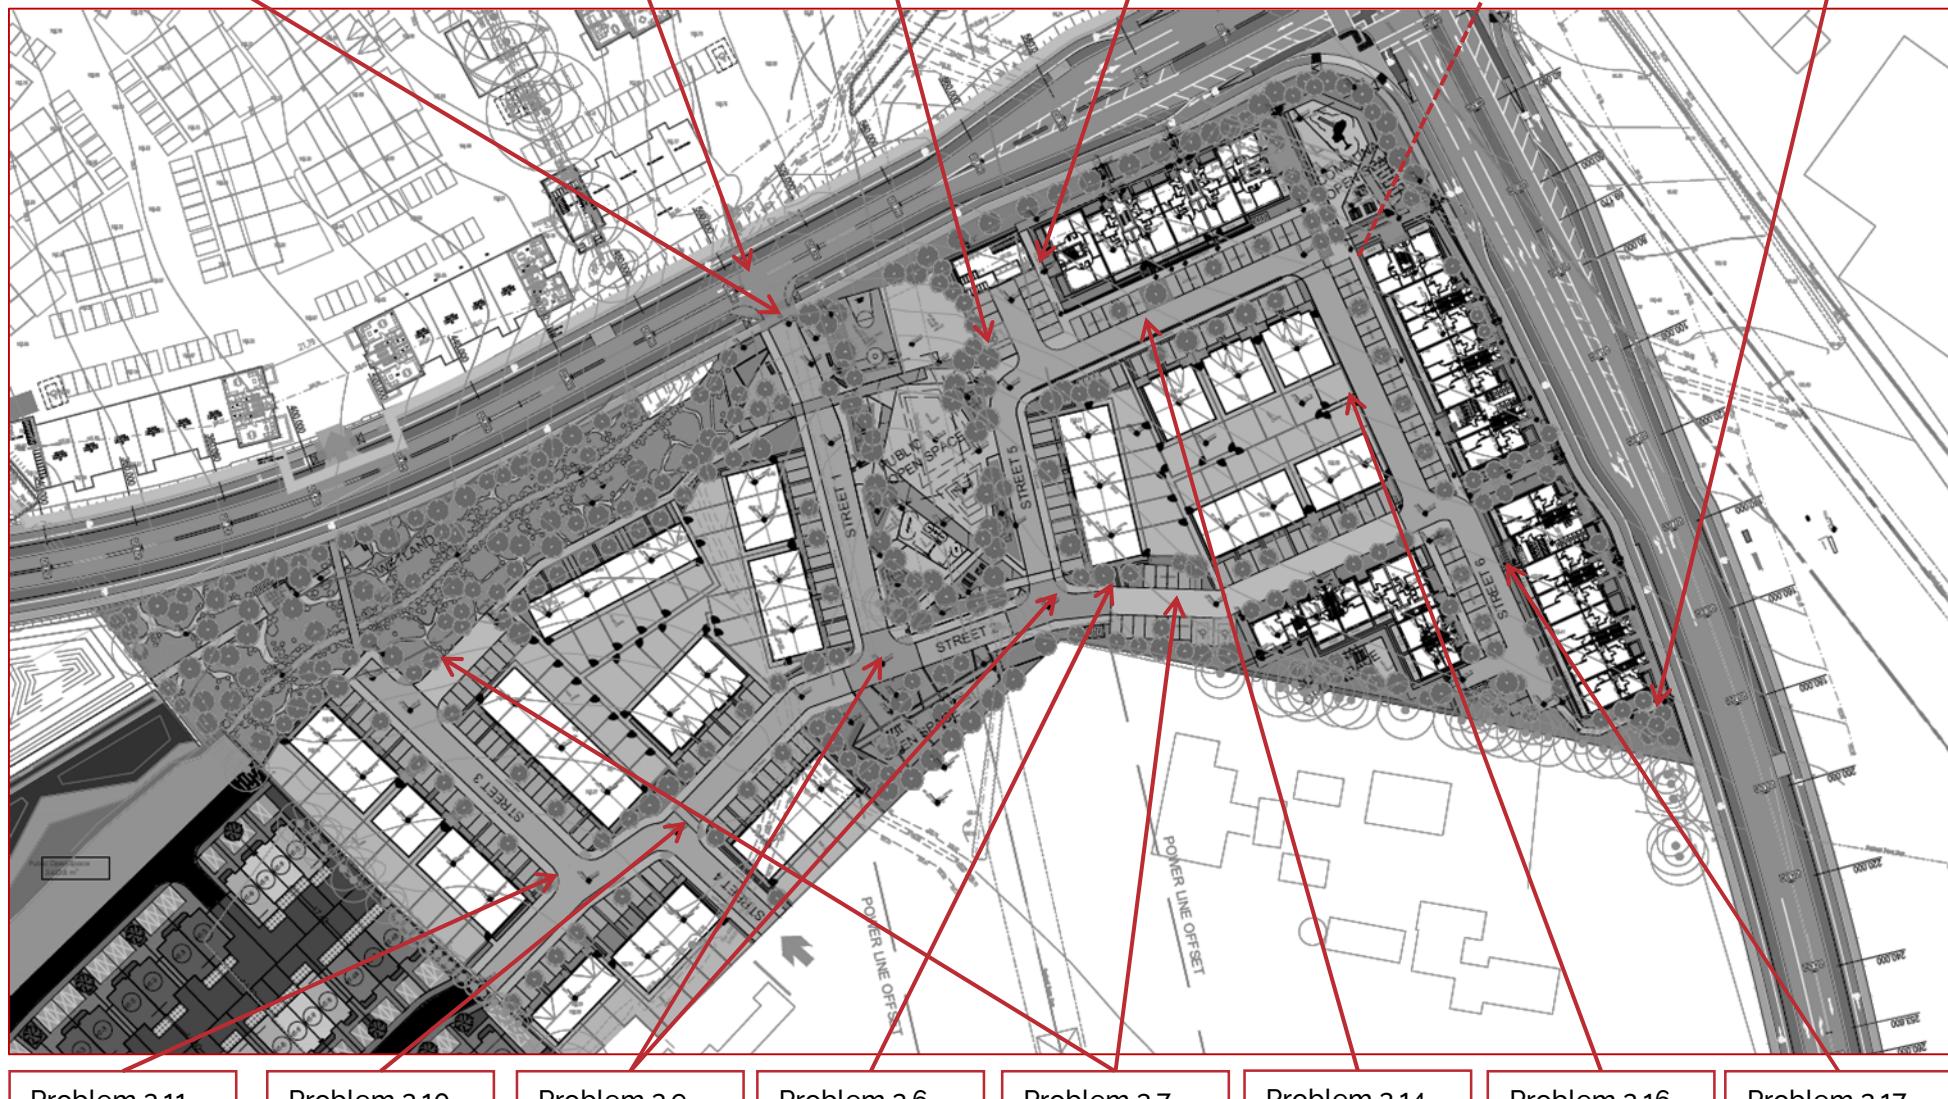
Problem 3.19

General Problem 3.12
General Problem 3.8
General Problem 3.15
